CTS Report: TS1004.2 (version for public release)
July, 2015 (original version submitted April 2015)

Insurance Claims Data Analysis for Cyclones Yasi and Larry

Report prepared by:
Daniel Smith and David Henderson
Cyclone Testing Station, JCU

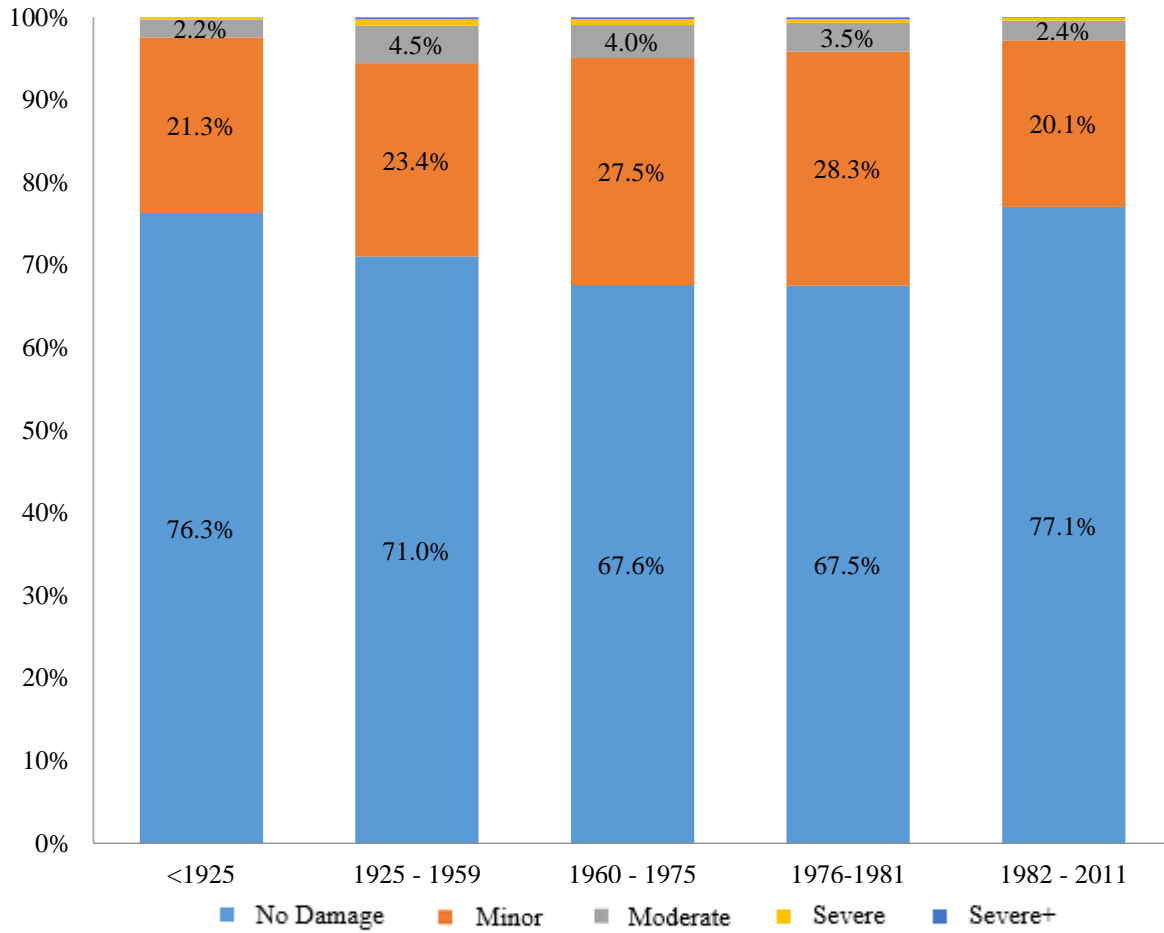
Figure 7. Building age vs damage type contributions to the total number of claims filed in relation to Cyclone Yasi for the North Queensland Coastal Region (note: “Severe” and “Severe+” bin proportions are less than 1% each and text omitted from this figure for clarity)

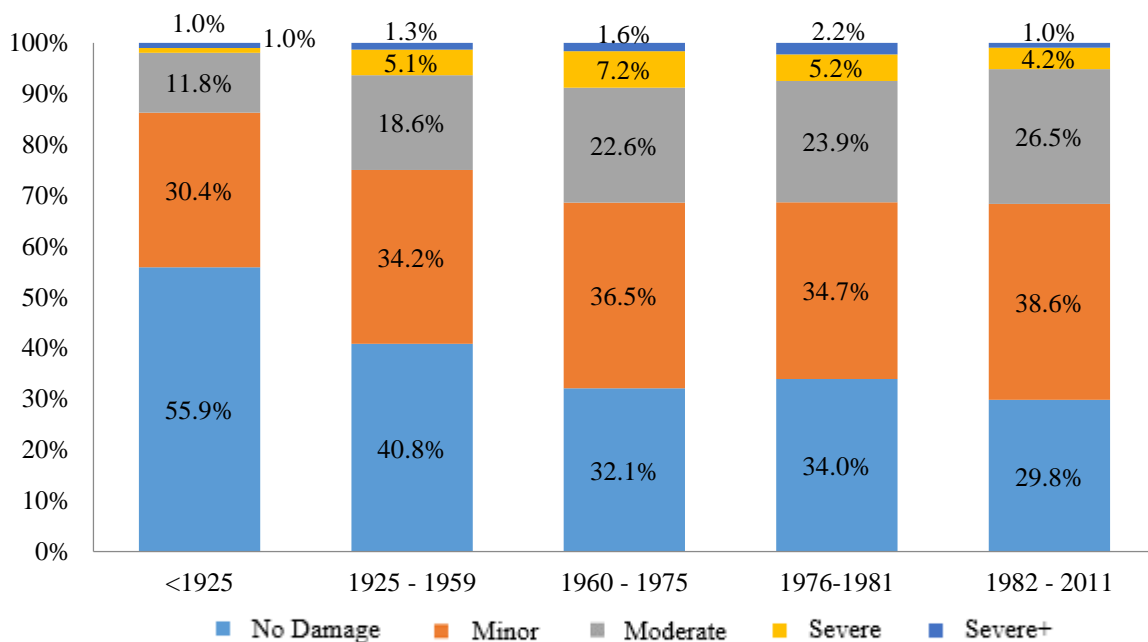
Figure 15. Building age vs loss ratio bin (see legend) contributions to the total number of claims filed in relation to Cyclone Yasi for the Tully/Mission Beach Region (note: “Severe” and “Severe+” bin proportions are less than 1% each and omitted from this figure for clarity)

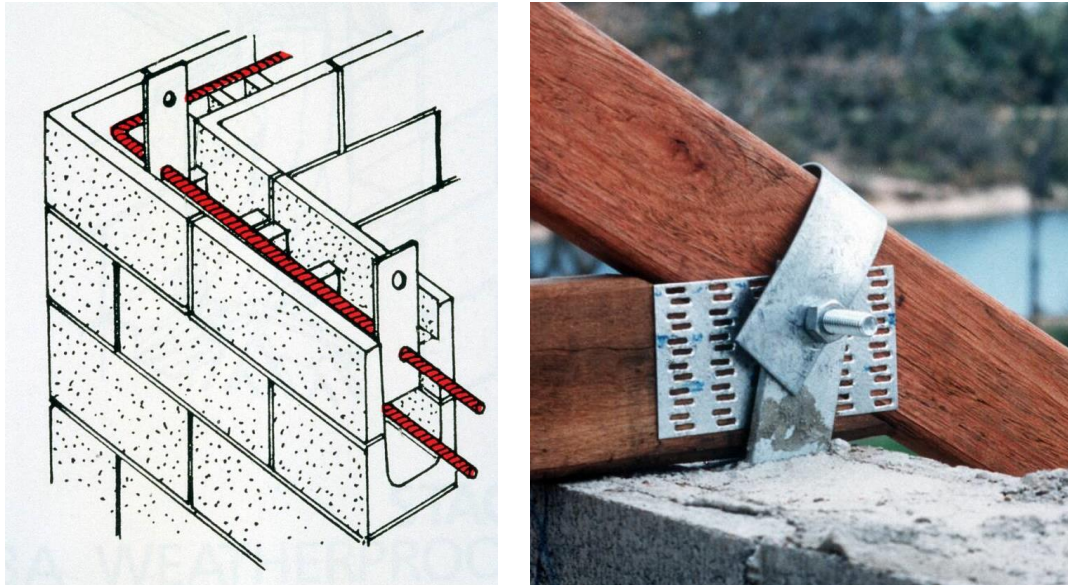
Reinforced masonry (concrete) block houses have become very common in North Queensland since the late 80s. Masonry blocks are bigger than traditional bricks and have large hollow sections called cores. Steel reinforcing is placed both vertically and horizontally in the cores which are then filled with concrete. The houses are built on concrete slabs (foundation) with the reinforcing starter embedded in the concrete slab to provide tie down and load path for the walls and roof. Horizontal steel reinforcement is used along with shear ties in the concrete bond beam at the top of the walls. The roof frame is generally timber, and is bolted to brackets or cleats on the bond beam (Figure 27).

Figure 25. Bond beam reinforcing and truss cleat plate (left) and cleat plate with overstrap providing hold down to hardwood truss in cyclonic region (right)

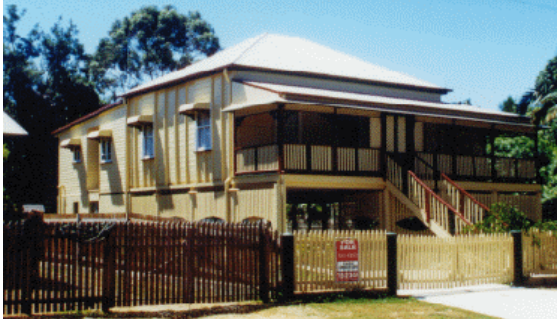
<p>Hip roof, reduced rafter spans, central core, exposed studs, on stumps (low and high)</p>
1925 – 1959

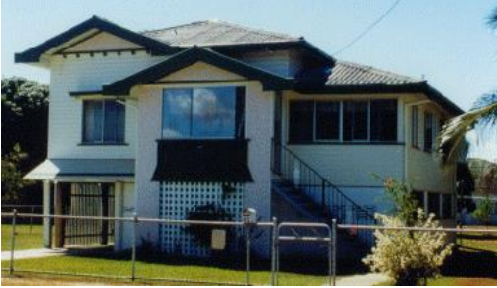
<p>Hip and gable, VJ lining, reduced rafter spans, on stumps (low and high)</p>
1960s – 1981

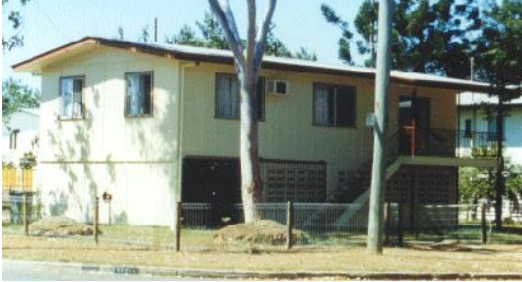
<p>Gable low pitch, vermin proof flooring (studs not mortice and tennon into bearers), panel cladding, on stumps</p>
1981 - present

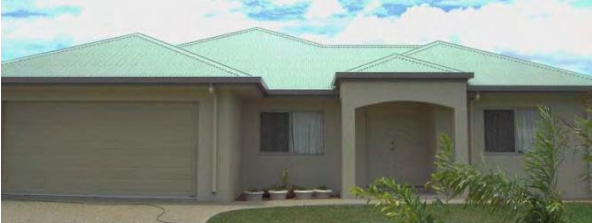
<p>Reinforced masonry block, hip and gable, large truss spans, medium roof pitch, slab on ground</p>
