**CTS Report: TS1004.2** (version for public release)  
**July, 2015** (original version submitted April 2015)

*Insurance Claims Data Analysis for Cyclones Yasi and Larry*

Daniel Smith and David Henderson  
Cyclone Testing Station, JCU

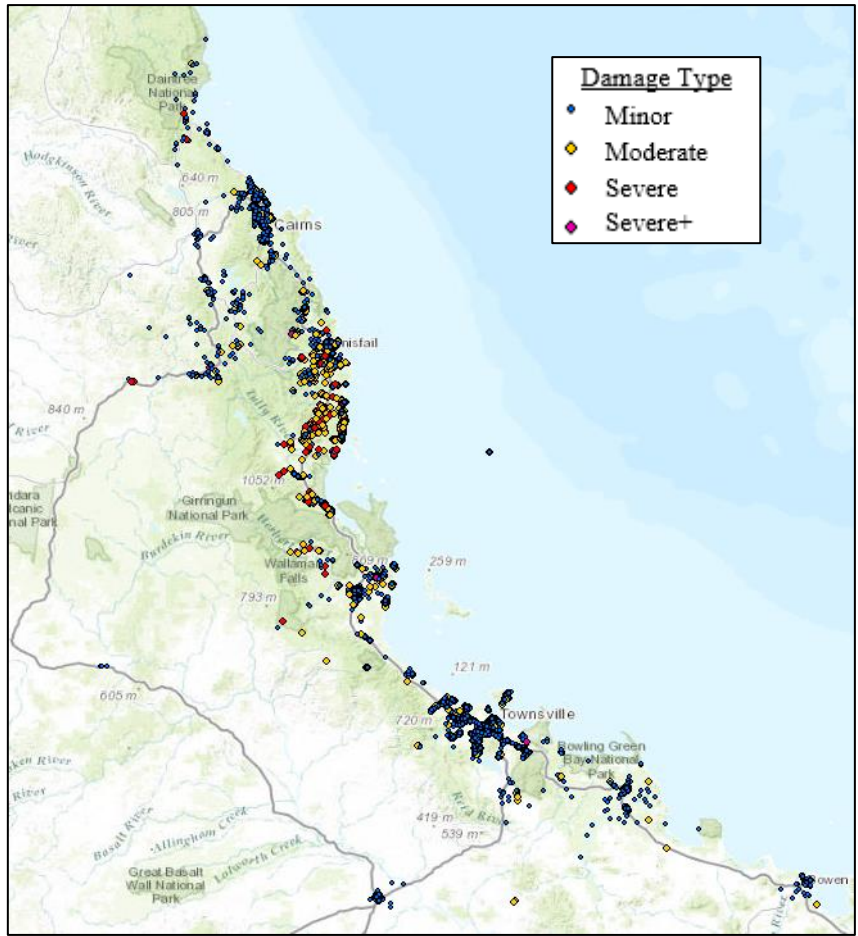
Figure 1. Northern Queensland Coastal Region impacted by Cyclone Yasi and selected for analysis including the distribution of damage types

Figure 1 shows the spatial distribution of properties falling within the four non-zero loss ratio bins (i.e. policies with claims) for the Northern Queensland Coastal Region. Figure 2 shows the estimated track for Cyclone Yasi and Figure 3 shows the estimated wind field near the point of landfall. As expected, loss ratios increase directly with wind speed. The frequency of large loss ratios (i.e. large claims) was greatest, in locations nearest the point of landfall (i.e. Cardwell, Mission Beach, etc.) where wind speed estimates were 210-240 km/h. However, claims were filed across the entire North Queensland region, even in areas of significantly lower wind speed (i.e. ~135 km/h in Townsville, ~90 km/h in Cairns).

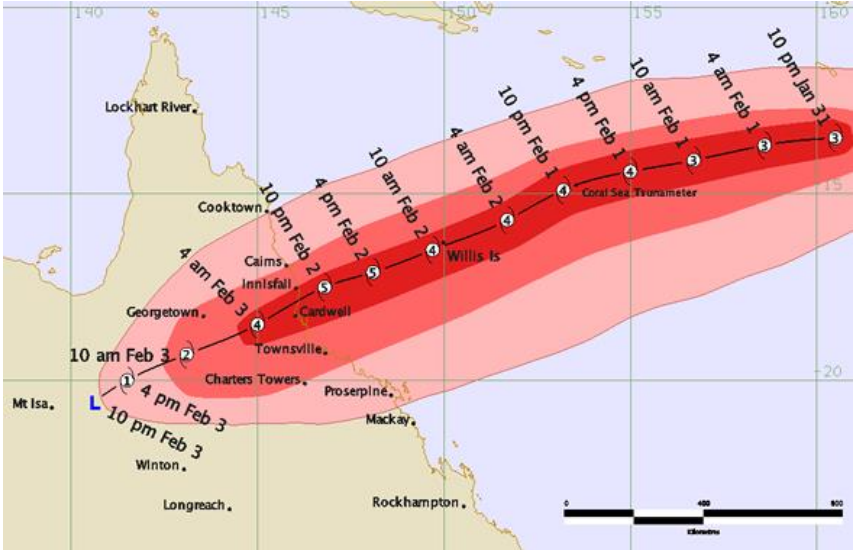
Figure 2. Cyclone Yasi track map before and after landfall (source: Bureau of Meteorology)

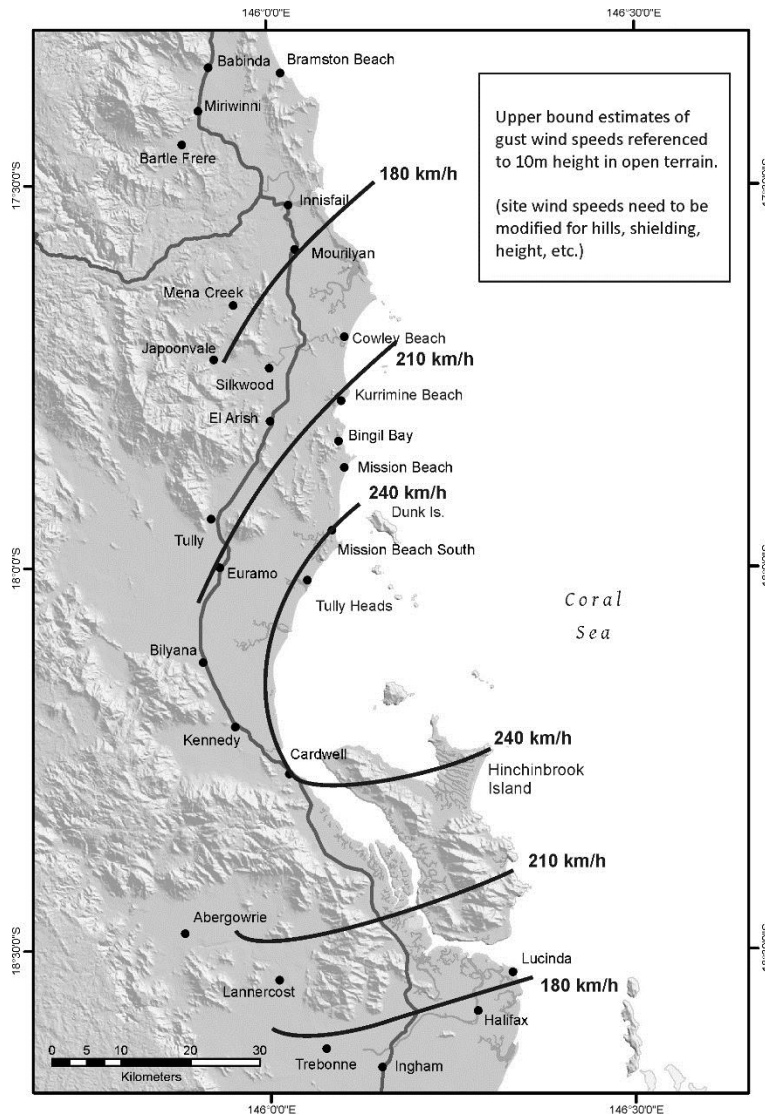
Figure 3. Cyclone Testing Station wind field estimation for Cyclone Yasi

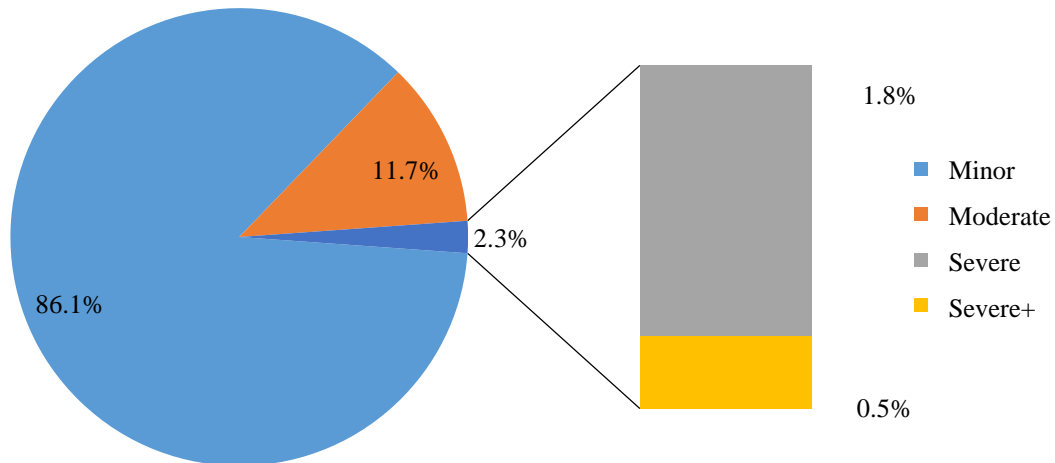
Figure 4. Proportions of damage types for the North Queensland Coastal Region

The claims filed in the North Queensland Coastal Region were separated into four bins based on loss ratio. Figure 4 shows the proportion and number of claims allocated to each bin.

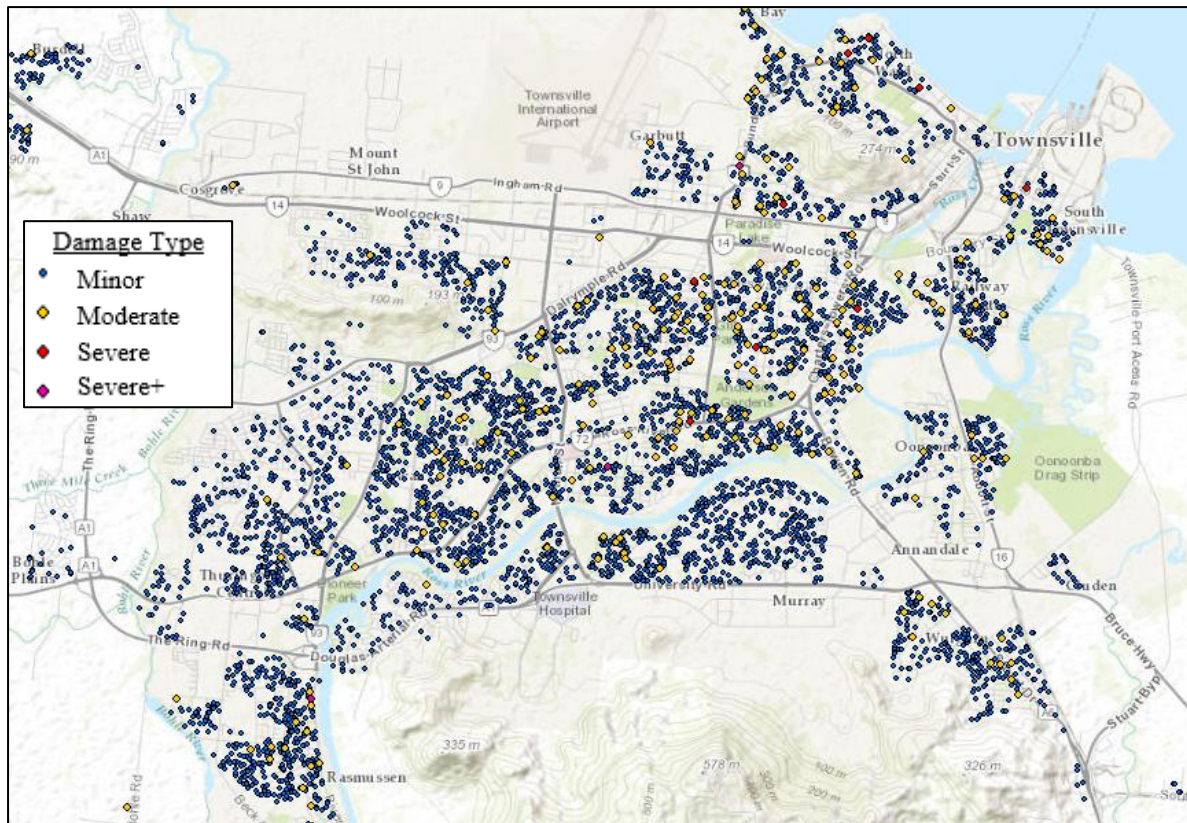
Figure 5. Locations and severity of damage across Townsville Region

Figure 5 shows the distribution of loss ratio by bin for the Townsville Region. Minor claims (loss ratio of 0-0.9) are dominant and occur uniformly throughout the region. The occurrence of minor claims appears to be independent of housing age and proximity to the coast. However, moderate and severe loss ratio claims (0.1-0.49 and 0.5-0.99) are more prevalent moving toward the coast where older housing is also prevalent.

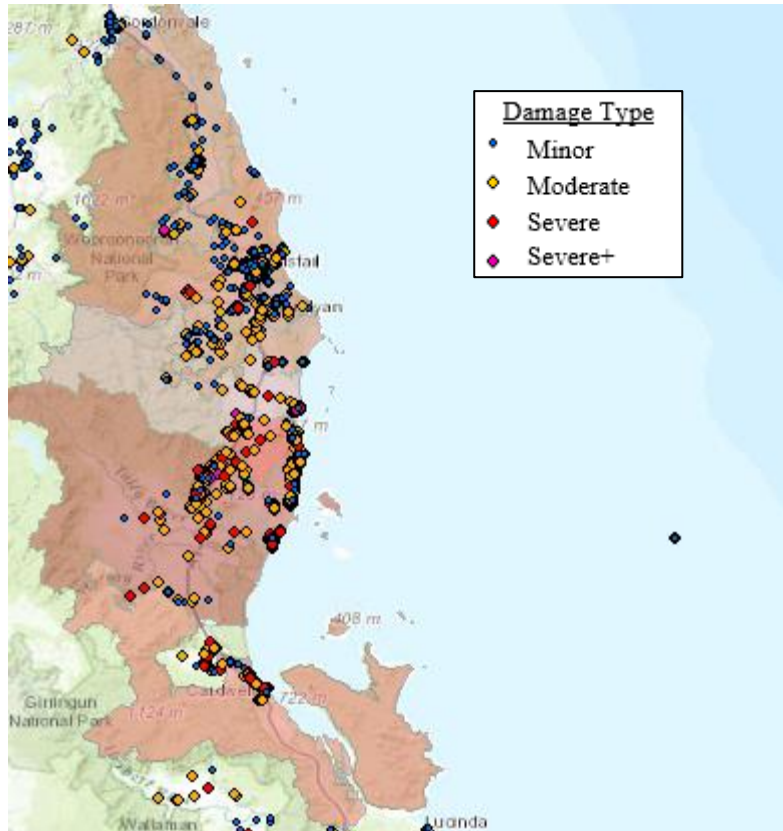
Figure 6. Locations and severity damage across the Tully/Mission Beach Region

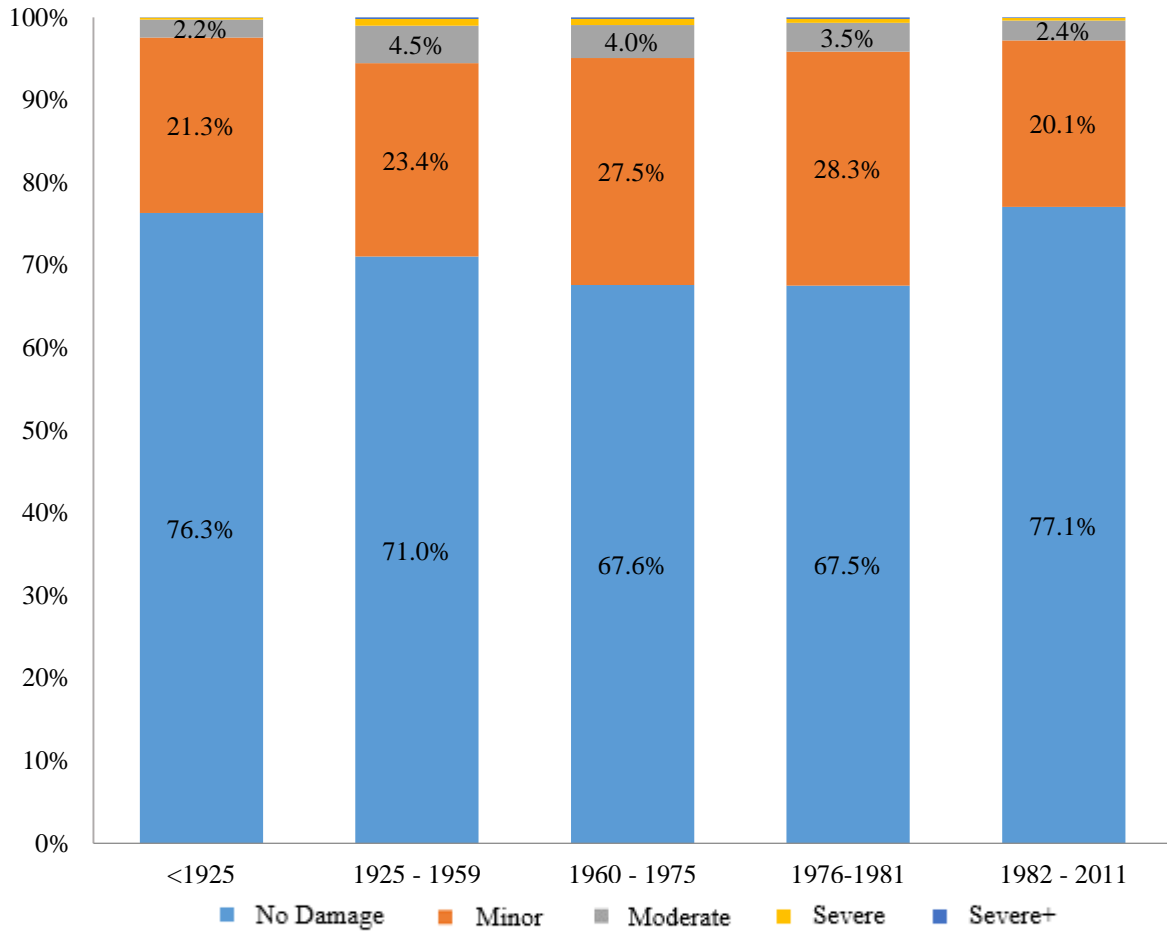
Figure 7. Building age vs damage type contributions to the total number of claims filed in relation to Cyclone Yasi for the North Queensland Coastal Region (note: “Severe” and “Severe+” bin proportions are less than 1% each and text omitted from this figure for clarity)

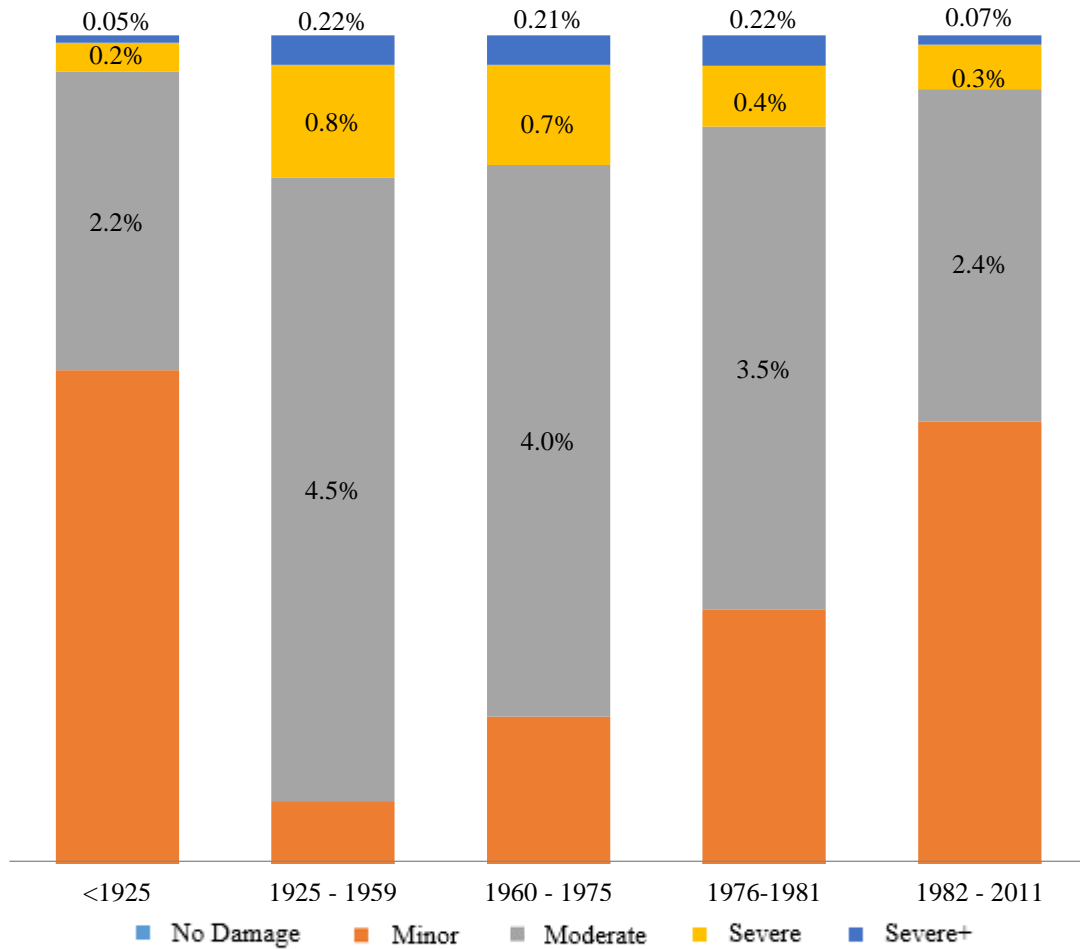
Figure 8. Building age vs damage type contributions to the total number of claims filed in relation to Cyclone Yasi for the North Queensland Coastal Region (Note: This figure is a magnified view of higher intensity damage types in Figure 7 per Suncorp request)

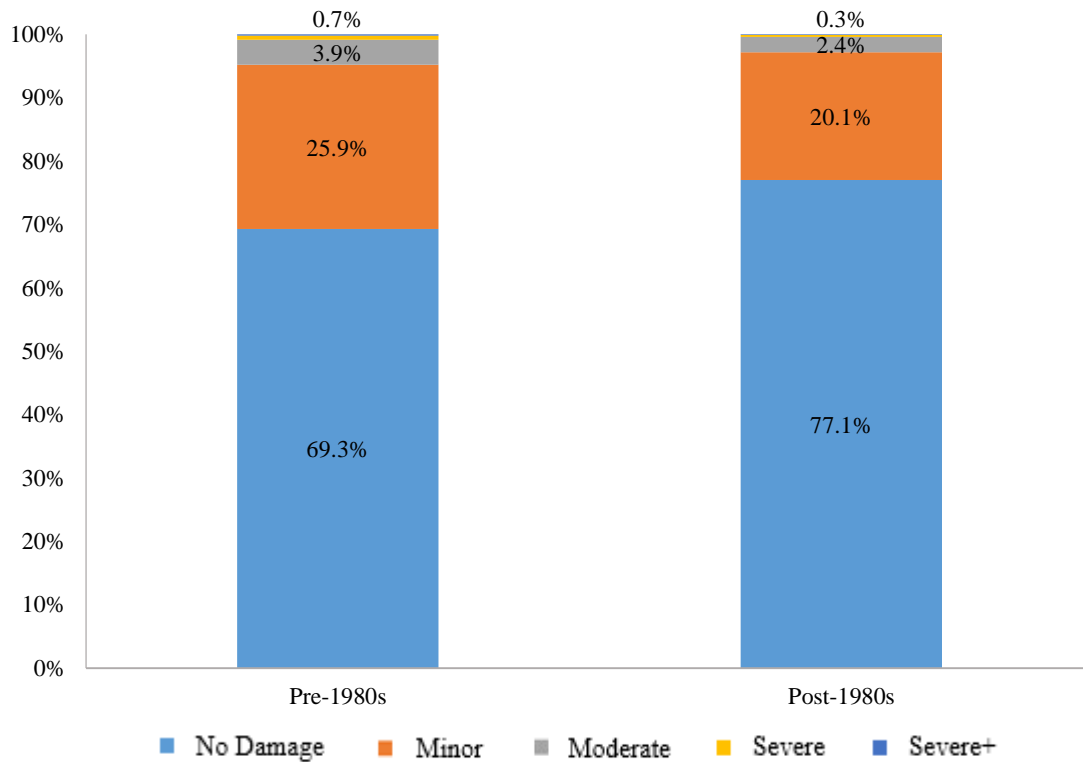
Figure 9. Building age vs damage type contributions (pre- and post-1980s) to the total number of claims filed in relation to Cyclone Yasi for the North Queensland Coastal Region (note: “Severe+” bin proportions are less than 1% each and omitted from this figure for clarity)

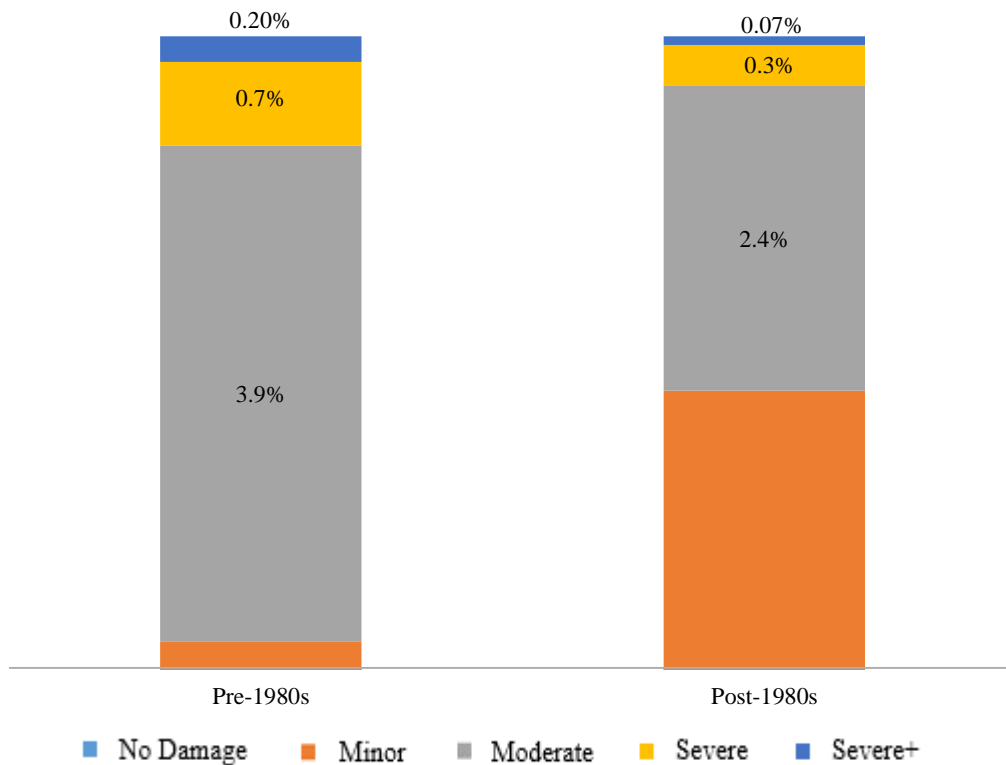
Figure 10. Building age vs damage type contributions (pre- and post-1980s) to the total number of claims filed in relation to Cyclone Yasi for the North Queensland Coastal Region (Note: This figure is a magnified view of higher intensity damage types in Figure 9 per Suncorp request)

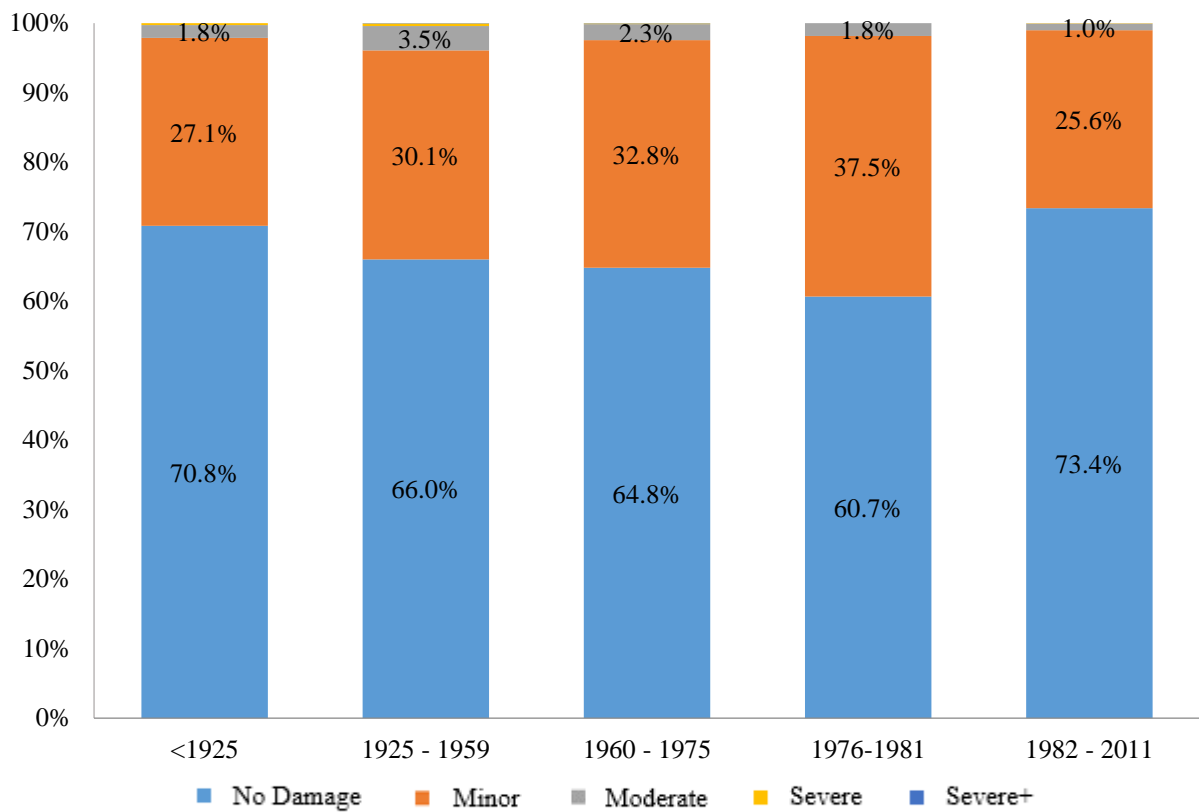
Figure 11. Building age vs damage type contributions to the total number of claims filed in relation to Cyclone Yasi for the Townsville Region (note: “Severe” and “Severe+” bin proportions are less than 1% each and omitted from this figure for clarity)

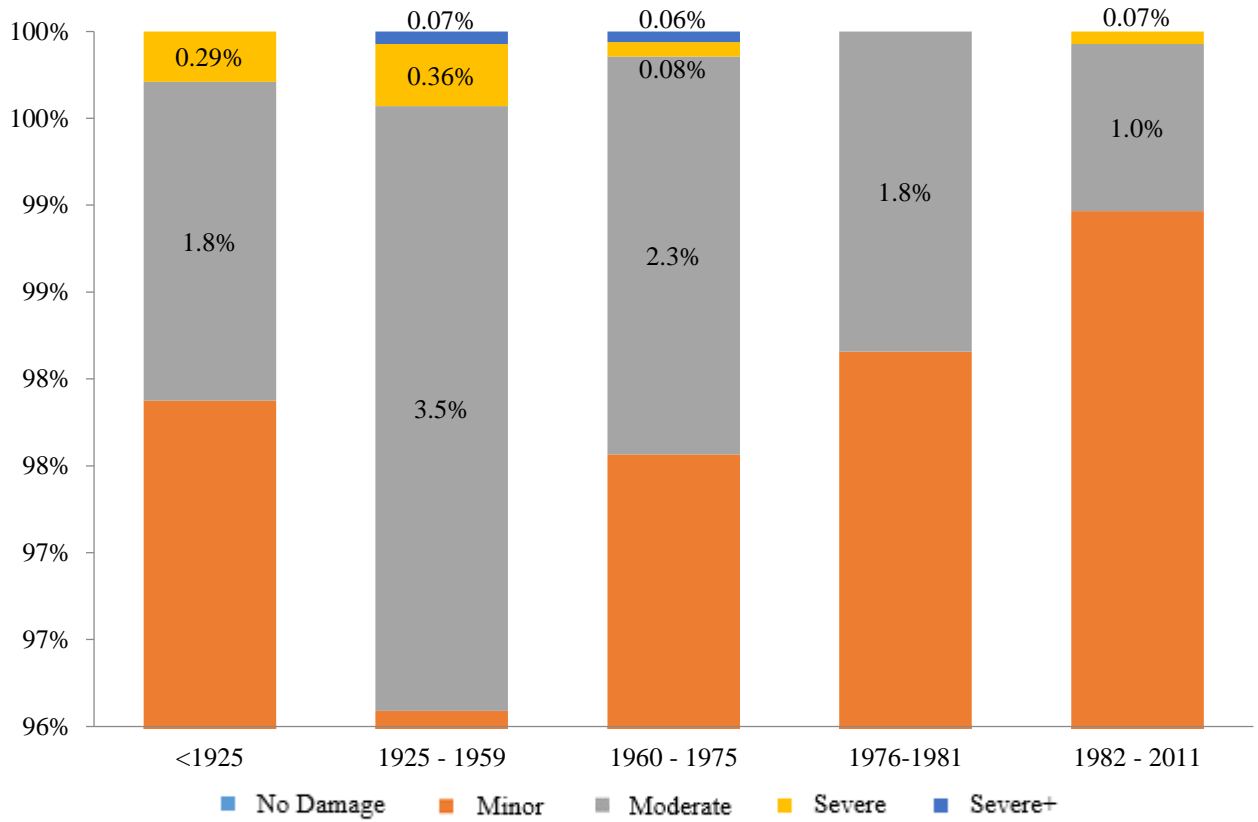
Figure 12. Building age vs damage type contributions to the total number of claims filed in relation to Cyclone Yasi for the Townsville Region (Note 2: This figure is a magnified view of higher intensity damage types in Figure 11 per Suncorp request)

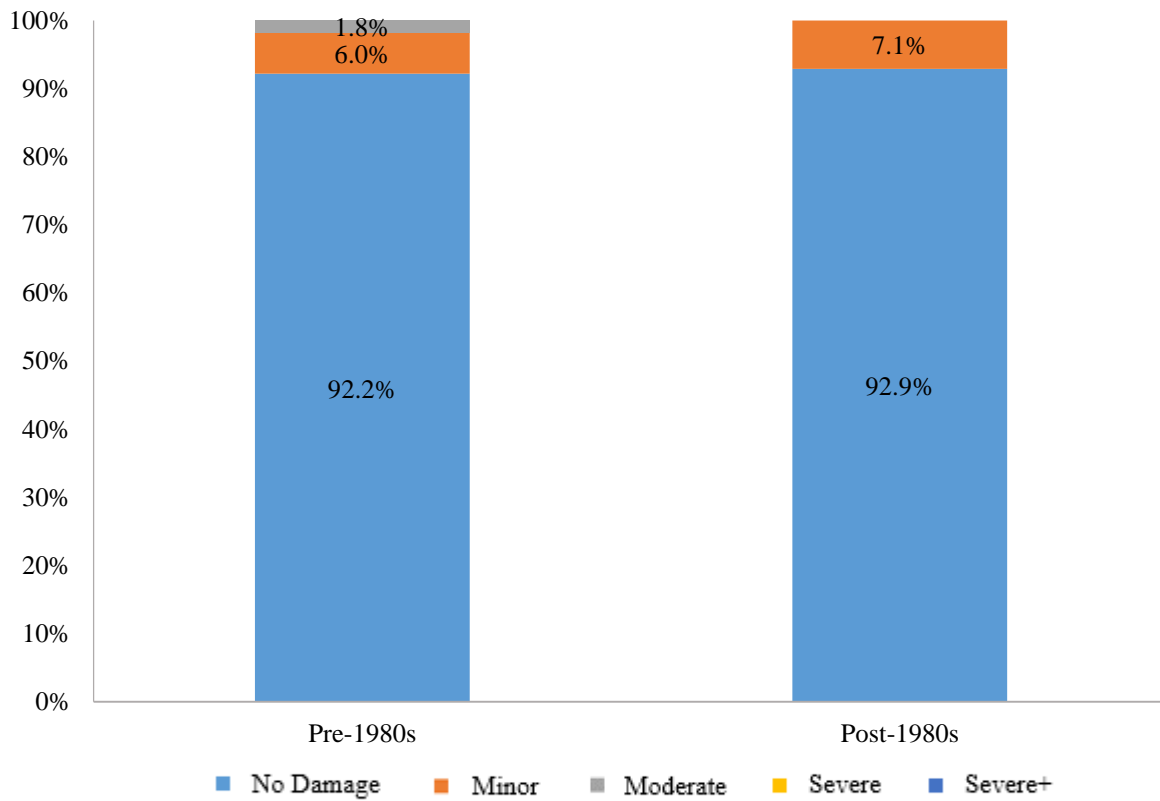
Figure 13. Building age vs damage type contributions (pre- and post-1980s) to the total number of claims filed in relation to Cyclone Yasi for the Townsville Region (note: “Severe” and “Severe+” bin proportions are less than 1% each and omitted from this figure for clarity)

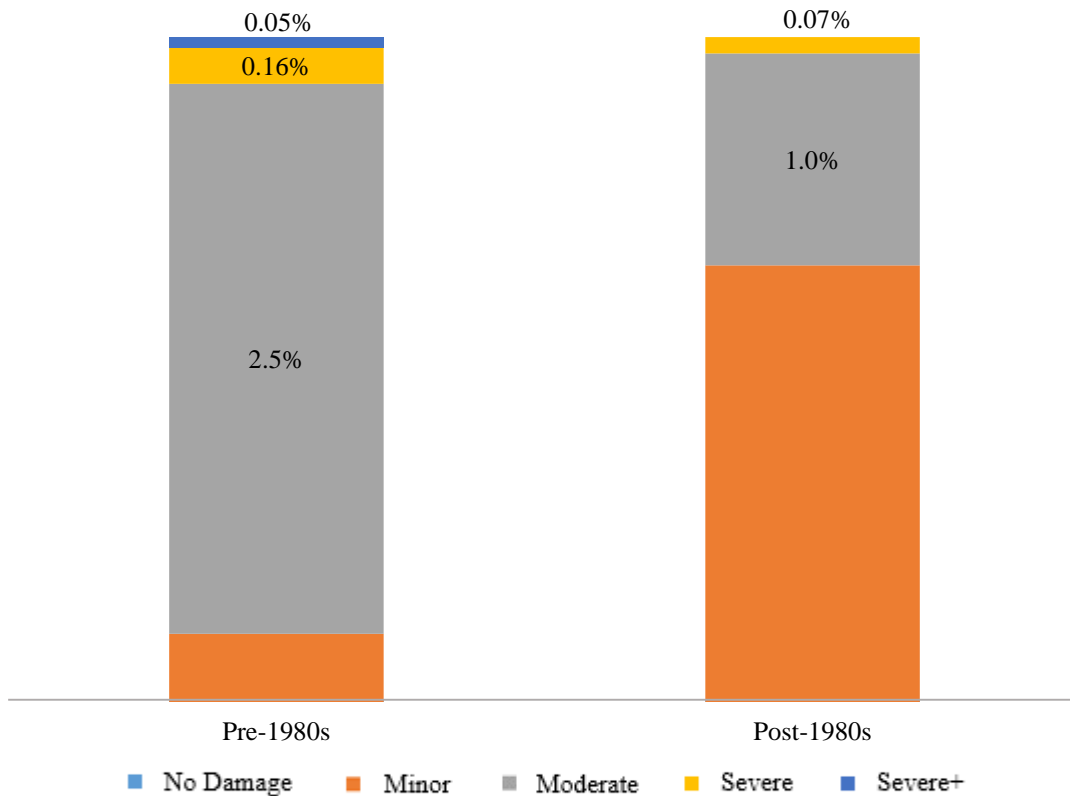
Figure 14. Building age vs damage type contributions (pre- and post-1980s) to the total number of claims filed in relation to Cyclone Yasi for the Townsville Region (Note 2: This figure is a magnified view of higher intensity damage types in Figure 13 per Suncorp request)

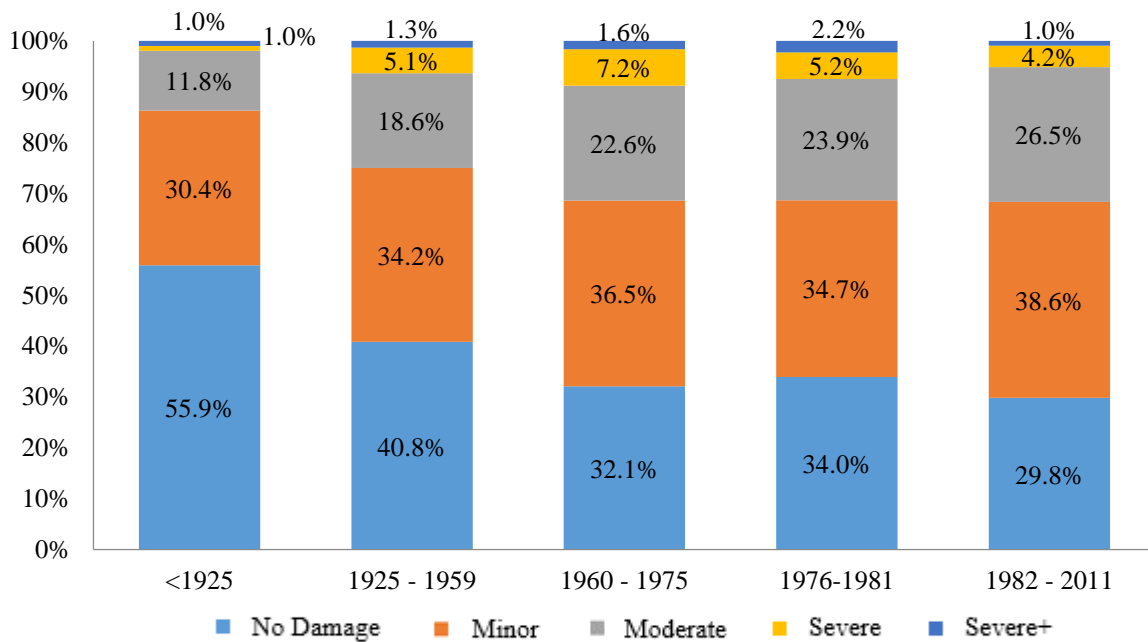
Figure 15. Building age vs loss ratio bin (see legend) contributions to the total number of claims filed in relation to Cyclone Yasi for the Tully/Mission Beach Region (note: “Severe” and “Severe+” bin proportions are less than 1% each and omitted from this figure for clarity)

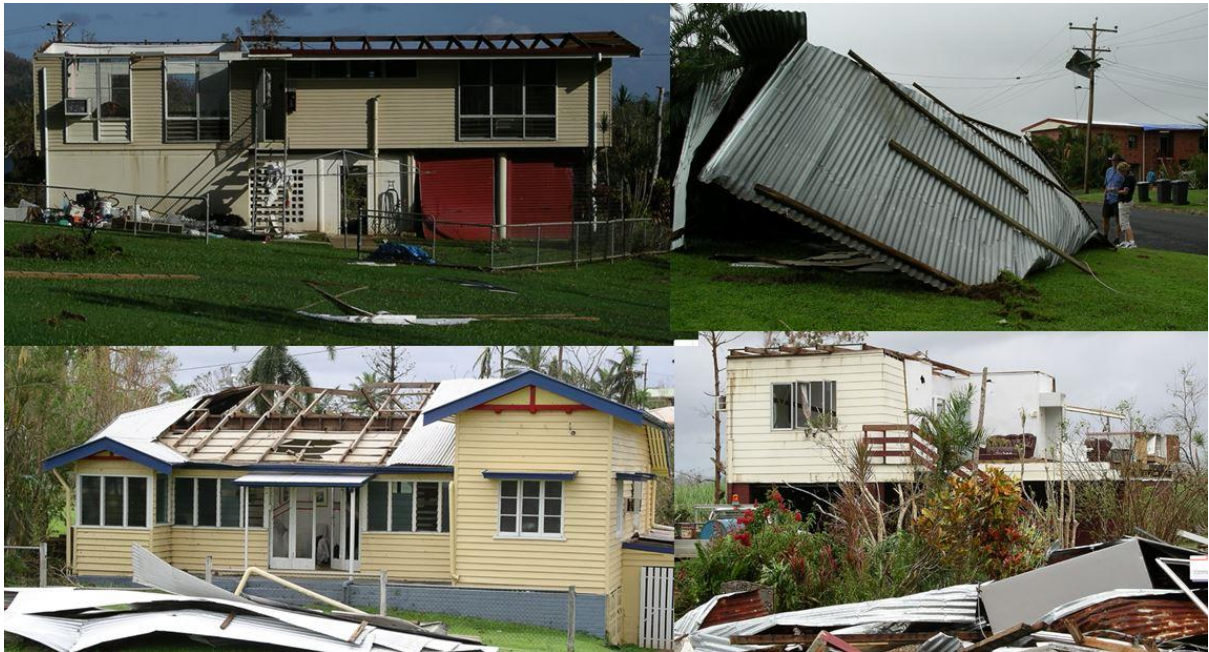
Figure 16. Examples of roofing failures from post-1980s housing following Cyclone Larry

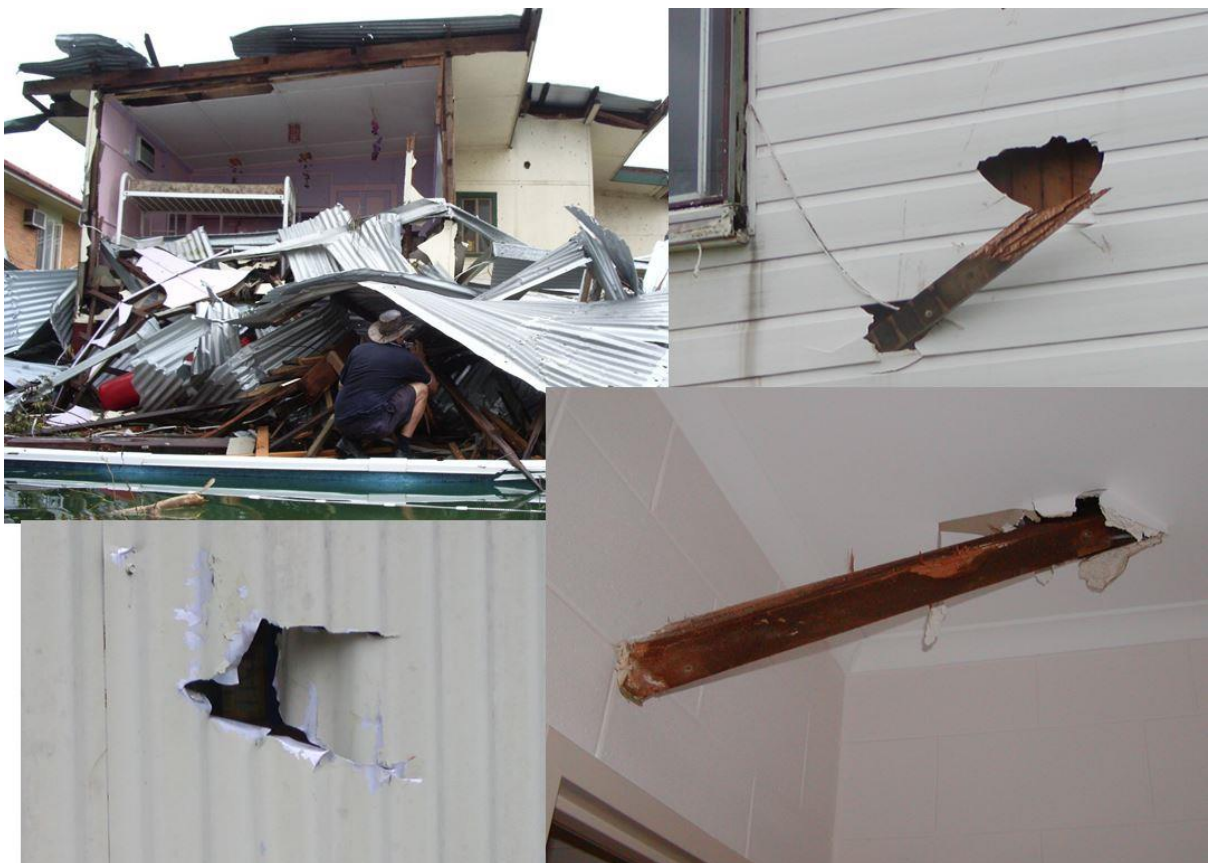
Figure 17. Wind-driven debris damage from structural failure of neighboring housing

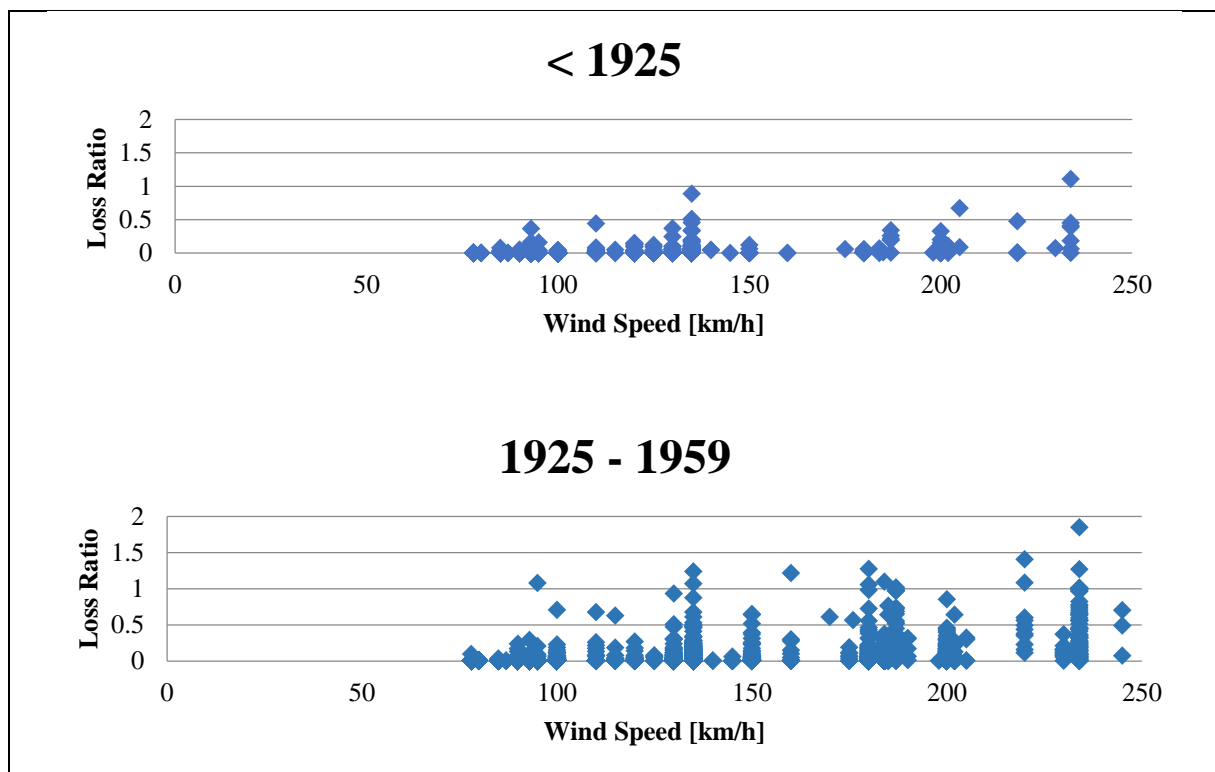
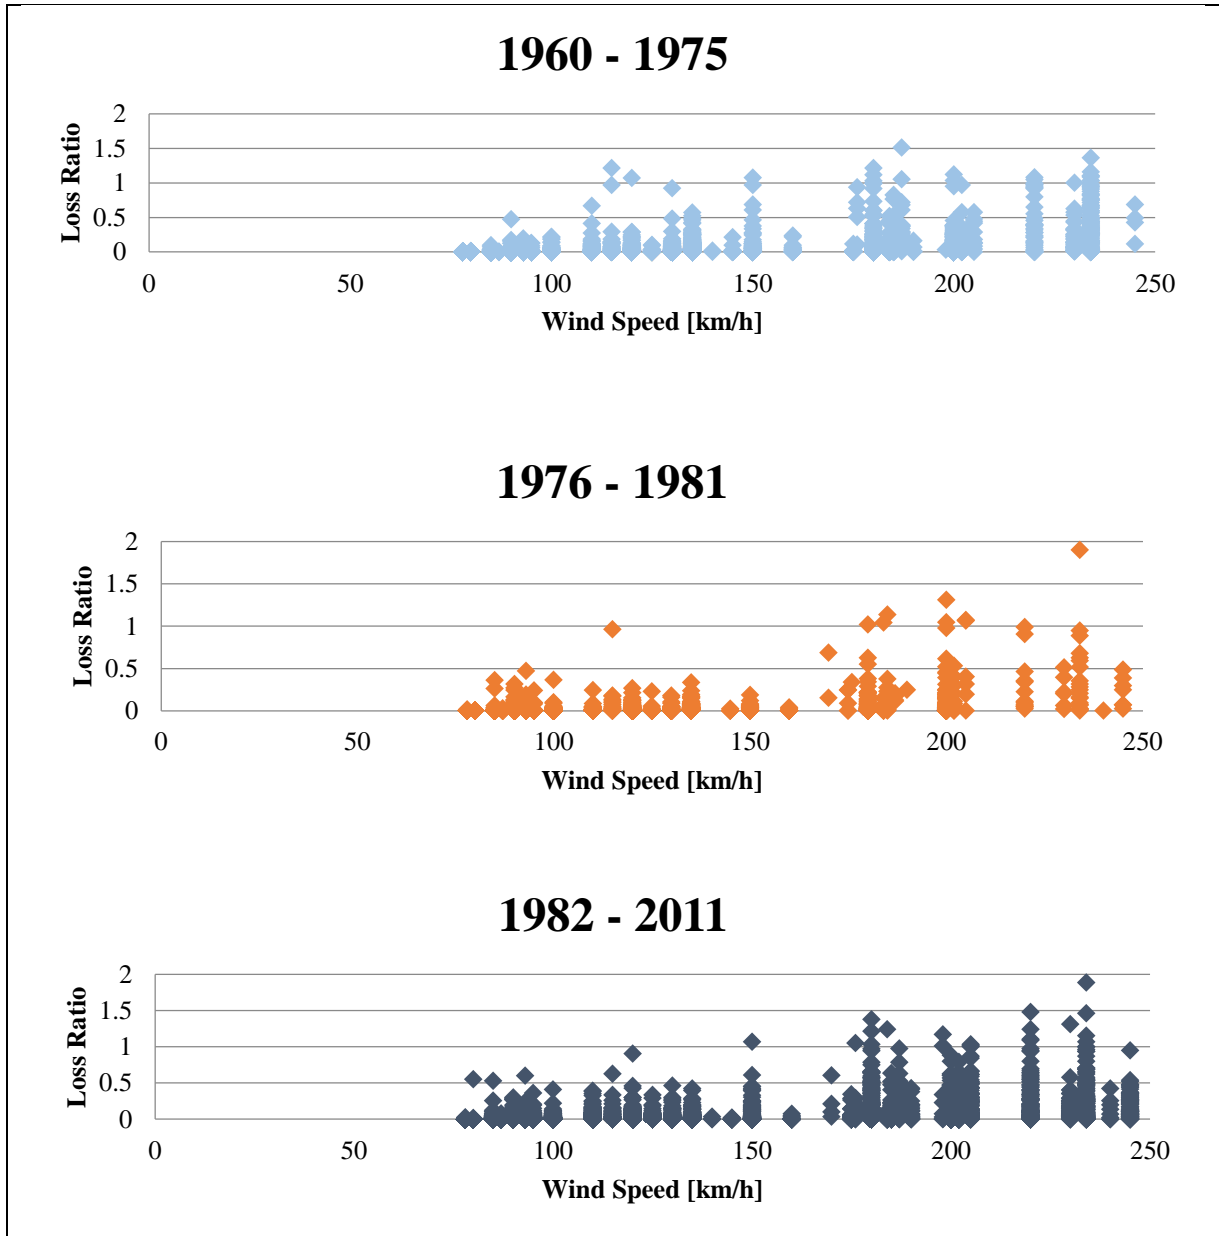
Figure 18. Loss ratio vs wind speed grouped by age for all claims in the North Queensland Coastal Region

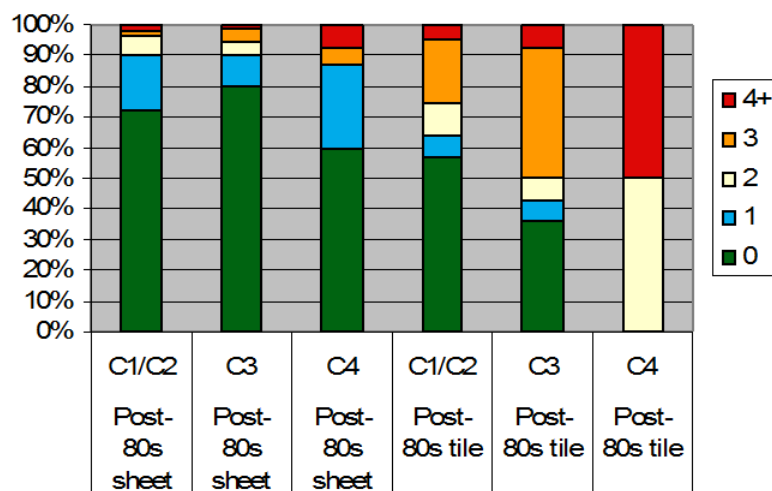
Figure 19. Roof damage index for post-1980s housing following TC Yasi determined from street survey data from the Cassowary Coast region (Boughton et al 2011)

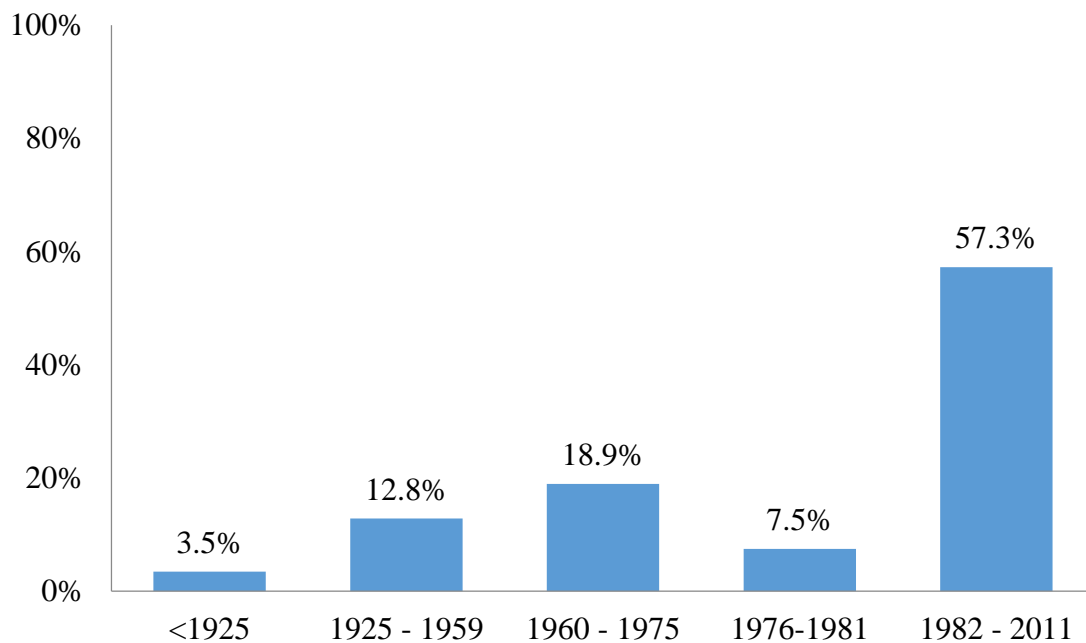
Figure 20. Proportions of property age groups in the North Queensland Coastal Region of analysis

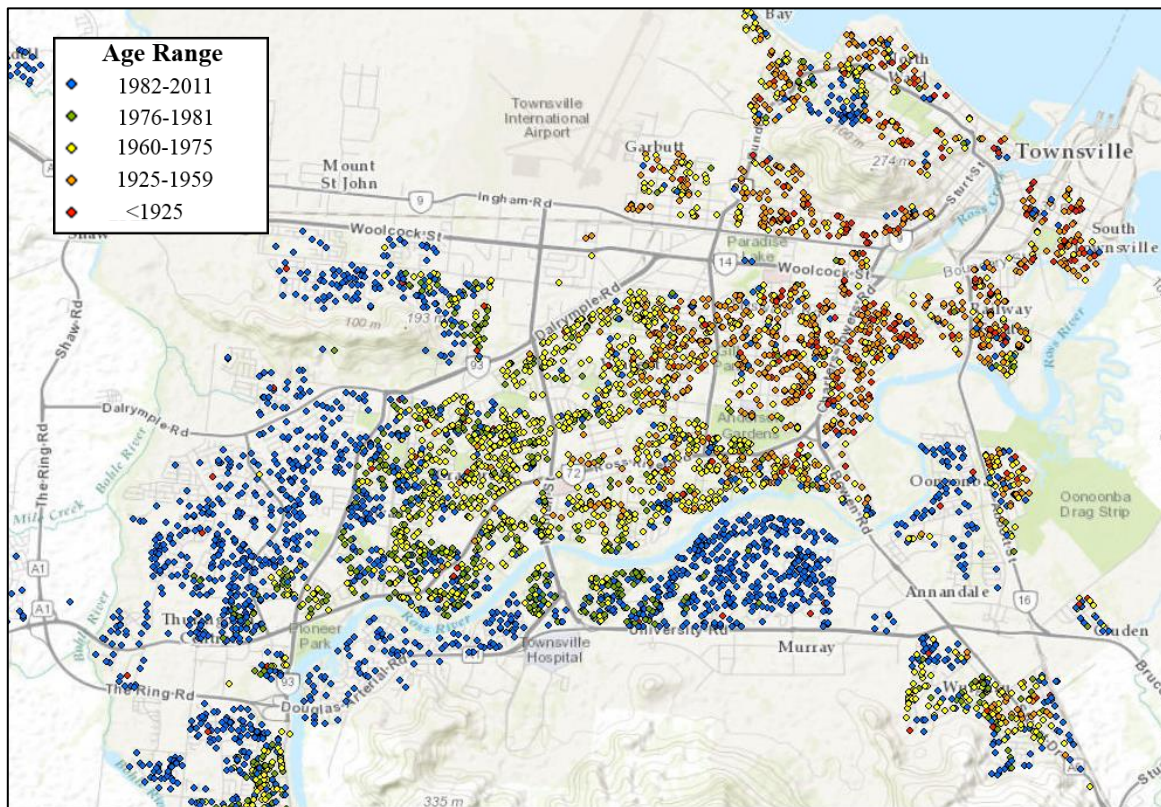
Figure 21. Distribution of property age groups across the Townsville Region

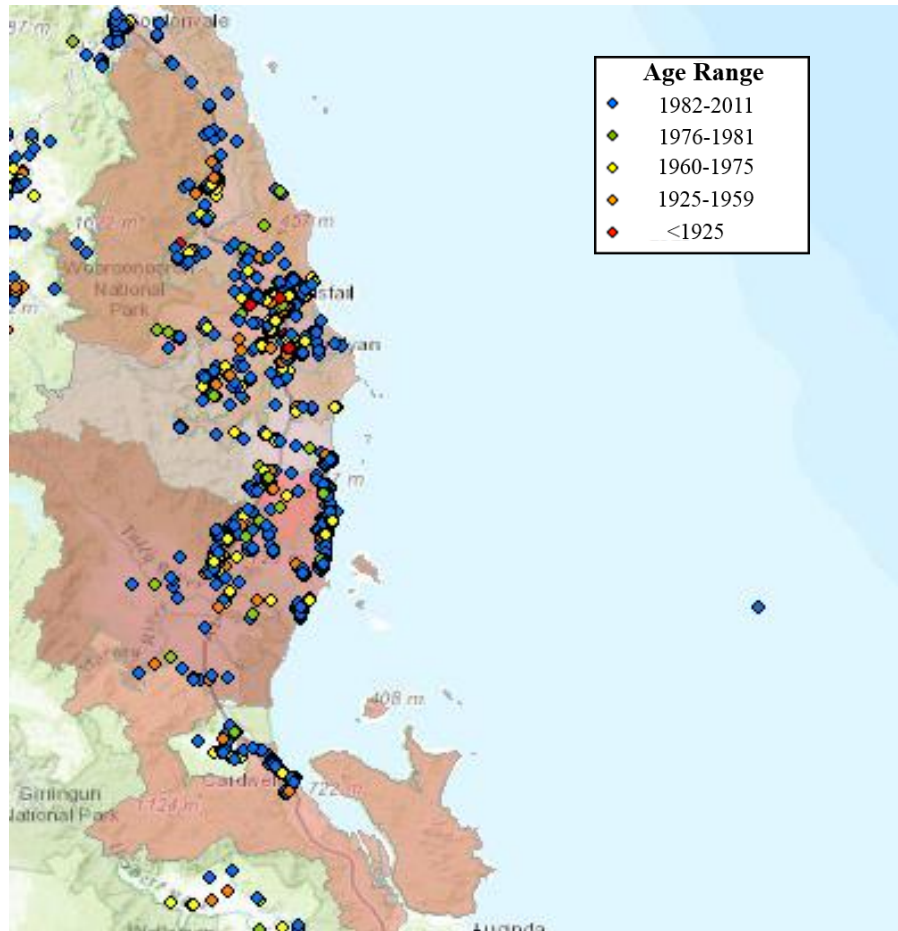
Figure 22. Distribution of property age groups across the Tully/Mission Beach Region

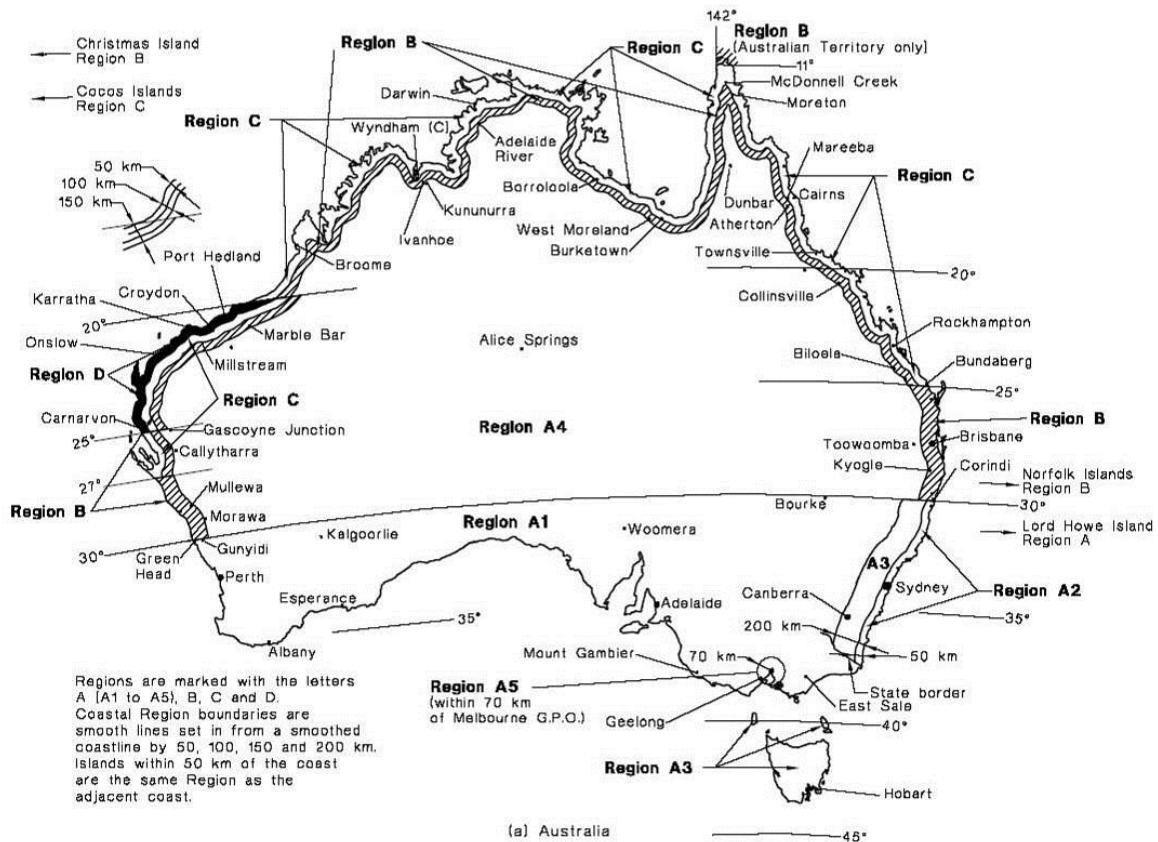
Figure 23. Wind Regions of Australia (AS/NZS-1170.2 2002)

These variations in weather systems are accounted for in the Australian and New Zealand Standard for structural design wind actions, AS/NZS 1170.2-2011, which divides Australia into several regions, as shown in Figure 25. Wind loads used in the design of structures (e.g. houses, shops, large storage sheds, 4 to 5 storey apartments, etc) are calculated from the data specified in AS/NZS 1170.2 which excludes tornados from its scope of wind actions.

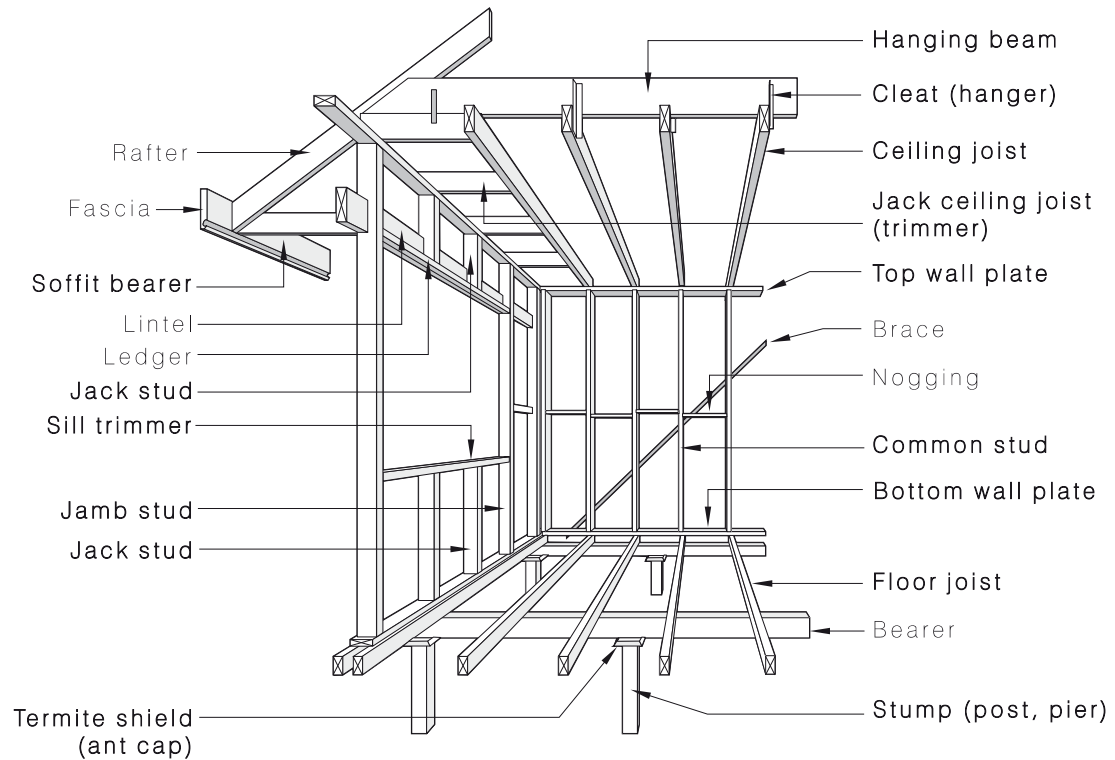
Figure 24. Typical arrangement of timber framing, Source: AS1684.3

Brick veneer housing uses typically a timber frame to provide the structural wind load resistance. The brickwork is merely a cladding that is supported horizontally by a timber frame. It consists of a single external brick layer which is attached to the timber frame using brick ties.
