**CTS Report: TS1004.2** (version for public release)  
**July, 2015** (original version submitted April 2015)

*Insurance Claims Data Analysis for Cyclones Yasi and Larry*

Daniel Smith and David Henderson  
Cyclone Testing Station, JCU

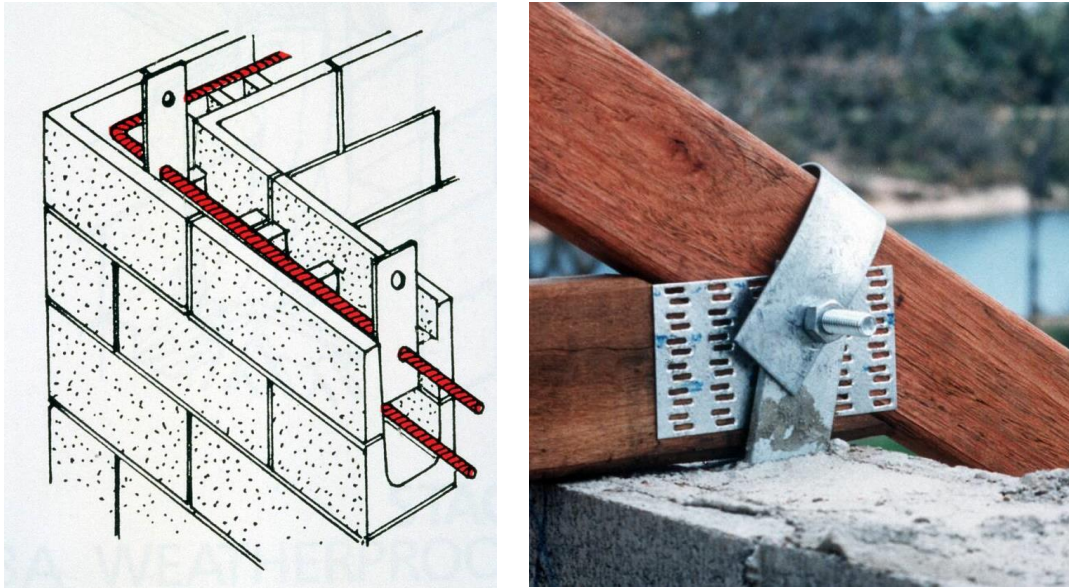
Figure 25. Bond beam reinforcing and truss cleat plate (left) and cleat plate with overstrap providing hold down to hardwood truss in cyclonic region (right)

Reinforced masonry (concrete) block houses have become very common in North Queensland since the late 80s. Masonry blocks are bigger than traditional bricks and have large hollow sections called cores. Steel reinforcing is placed both vertically and horizontally in the cores which are then filled with concrete. The houses are built on concrete slabs (foundation) with the reinforcing starter embedded in the concrete slab to provide tie down and load path for the walls and roof. Horizontal steel reinforcement is used along with shear ties in the concrete bond beam at the top of the walls. The roof frame is generally timber, and is bolted to brackets or cleats on the bond beam (Figure 27).

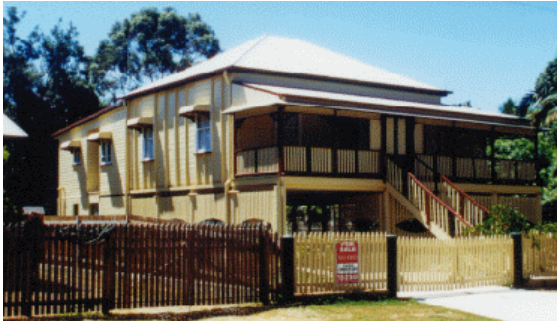
<p>Hip roof, reduced rafter spans, central core, exposed studs, on stumps (low and high)</p>
1925 – 1959

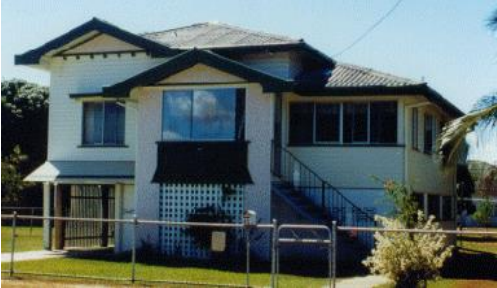
<p>Hip and gable, VJ lining, reduced rafter spans, on stumps (low and high)</p>
1960s – 1981

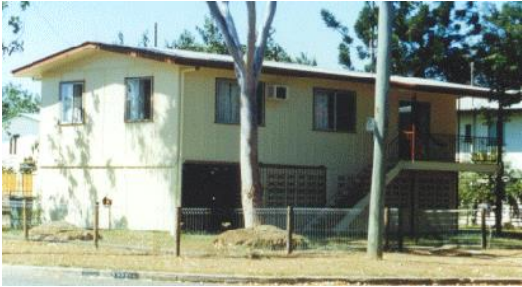
<p>Gable low pitch, vermin proof flooring (studs not mortice and tennon into bearers), panel cladding, on stumps</p>
1981 - present

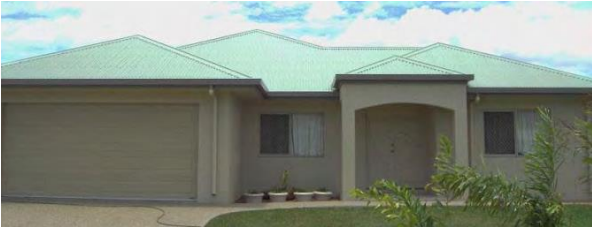
<p>Reinforced masonry block, hip and gable, large truss spans, medium roof pitch, slab on ground</p>

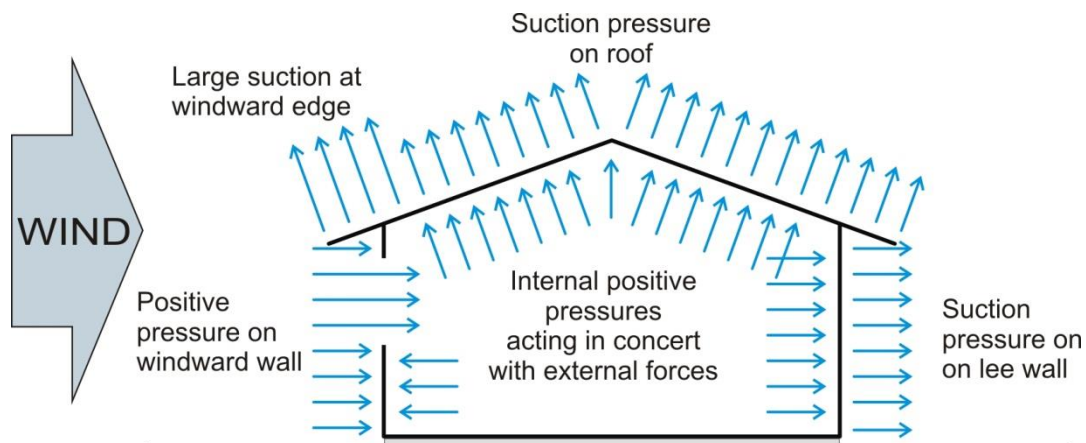
Figure 26. Simplified representation of wind pressures acting on building

The loads induced by wind flow are also affected by the terrain over which it blows (e.g. accelerates up a slope; reduces with increasing terrain roughness such as suburbs as opposed to open fields; and increases with height above ground) and by shielding from nearby similarly sized objects such as houses immediately in front of the “target” house.

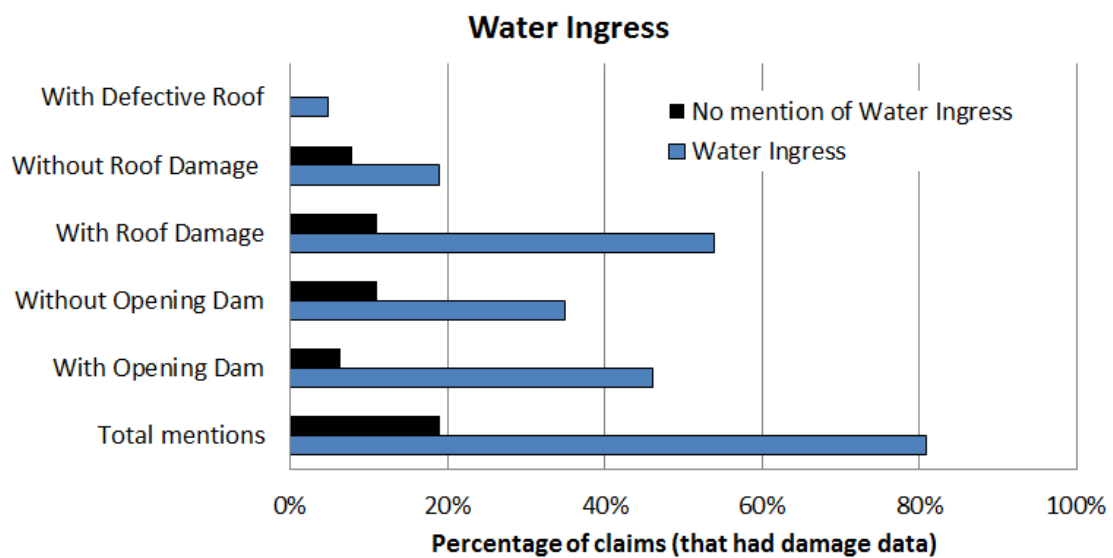
Figure 27. Wind driven rain water ingress damage from insurance claims data (Henderson 2013)

The CTS conducted a study for the Insurance Council of Australia on insured losses in strata properties suffered during Cyclone Yasi (Henderson 2013). The study found 80% of claims noted damage resulting from water ingress (Figure 29). This result is strikingly similar to that of a survey following Cyclone Larry (Melita 2007) showing 75% of contemporary houses having envelope damage and water ingress. All this damage was from wind speeds far less than the structural design wind speeds as set out in the National Construction Code. From analysing the available strata claims and ratios of losses to sum insured (LR/SI) it can be inferred that approximately one quarter of the claims were associated with wind driven rain entering via the building envelope (roof space, windows, doors, etc) without mention of structural or other damage to breaching the envelope. These claims account for 20% of the total losses – just from wind driven rain ingress via “undamaged/code compliant” building envelope (Henderson 2013).

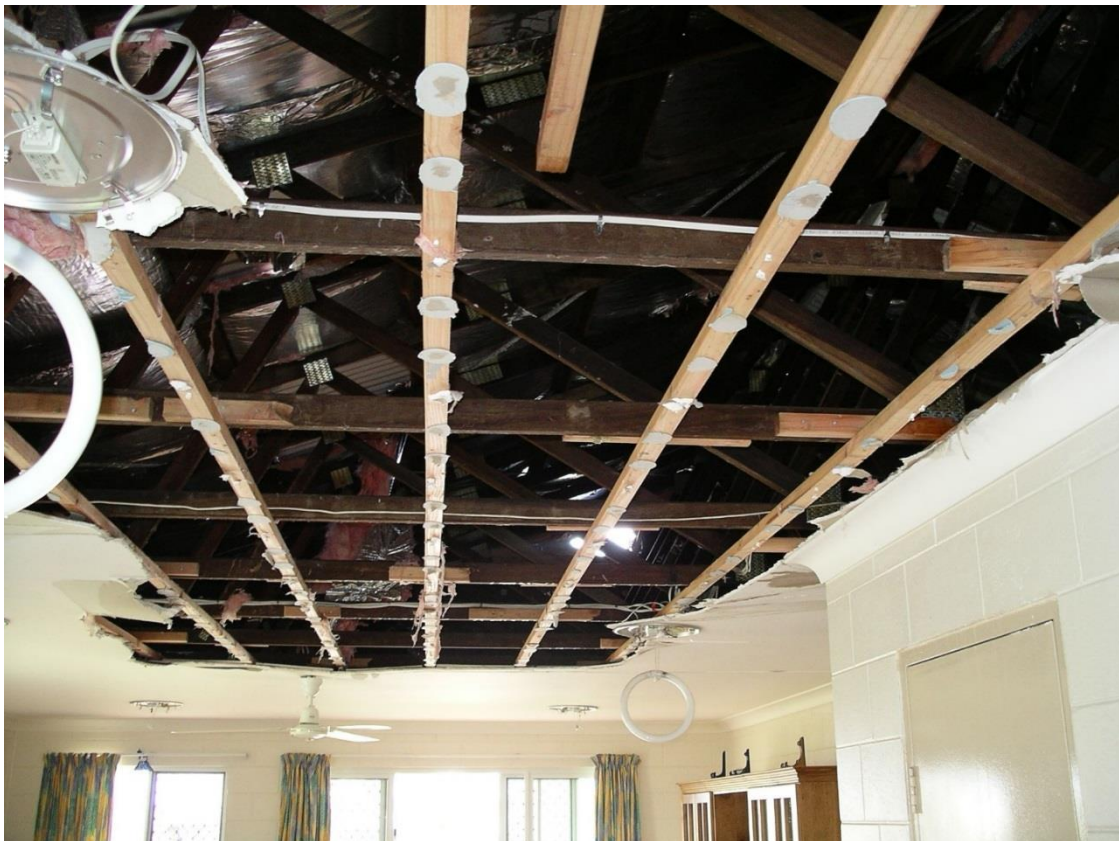
Figure 28. Damage to ceiling and fittings from wind driven rain via in part debris damage to gable end (TC Larry)

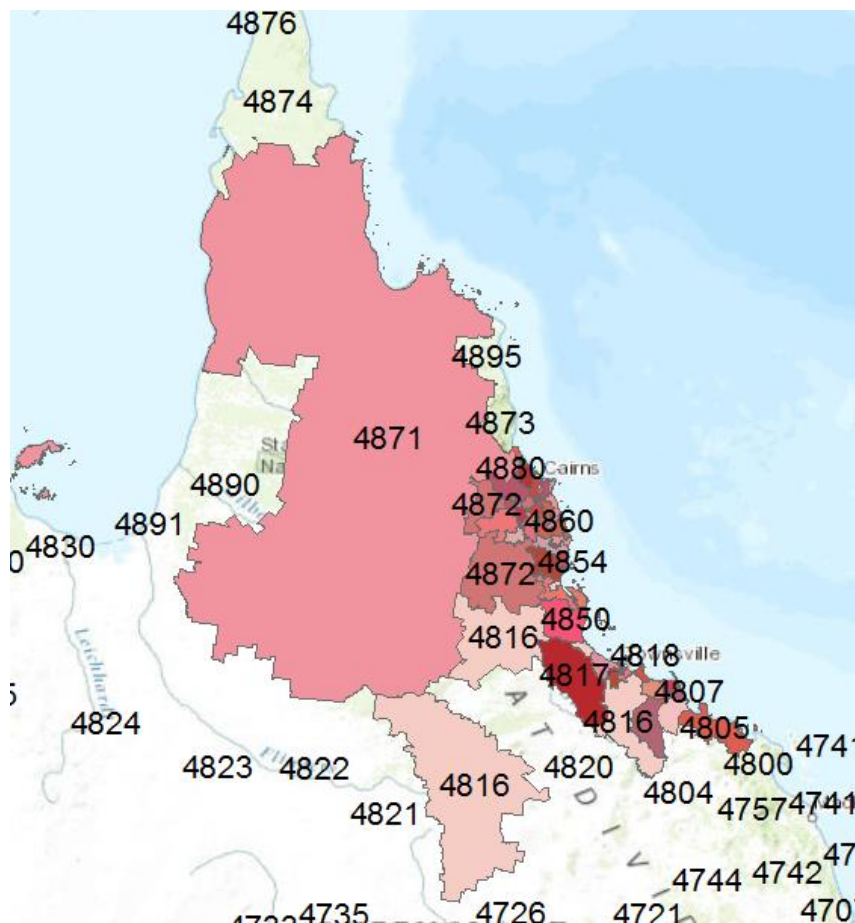
Figure 29. Geographic postal code regions in North Queensland

In order to isolate regions that were predominantly impacted by wind during Cyclone Yasi, the coastal region of North Queensland extending from Bowen to Port Douglas was selected for analysis. In the first instance, this area was to be selected by post-codes located along the coast (Figure 31). However, it was discovered that several post-codes include multiple non-continuous geographic regions (e.g. see post code 4816), with some regions located in coastal areas and others located farther inland. These multi-region postal codes were removed from the Northern Queensland Coastal Region analysis for simplicity and alignment with the range of estimated wind speeds by region that the Cyclone Testing Station developed after Cyclone Yasi. The selected analysis region is shown in Figure 32.

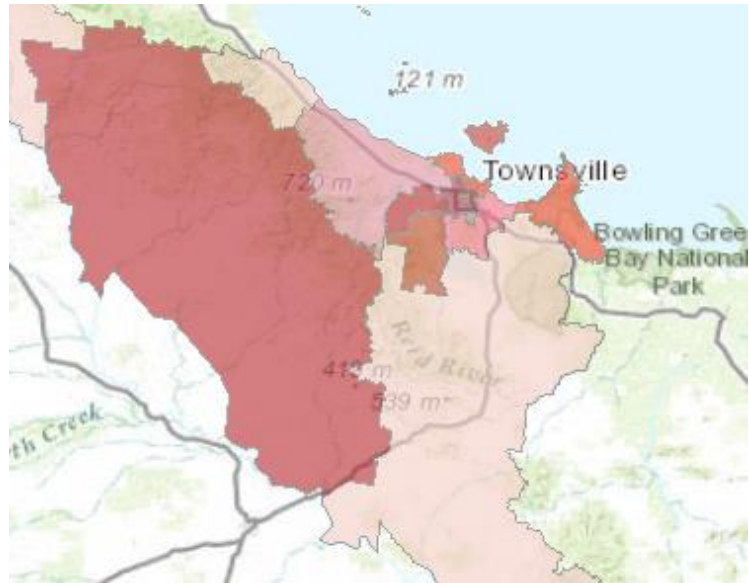
Figure 31. Postcodes in the Townsville study area

Due to the relatively large wind bands generated by Cyclone Yasi, the entire Townsville area in broad brush terms can be assumed for this study to have been subjected to a similar range of relatively low wind speeds, wind directions, and rain fall intensity. Hence, analysis of Townsville Region allowed performance comparisons between housing of various construction ages while limiting the uncertainty associated with variations in wind speed. Figure 33 defines the Townsville region by post-code, which extends from Alligator Creek to Bushland Beach. Of the policies within the Townsville Region, 30% filed a claim associated with Cyclone Yasi for a wind event which was about half of the wind load structural design criteria.
